Manhole Inspection Summary

Manhole # S09OO_019MH

Insp Date: **8/10/07 12:26 PM**

Location Address: **3400 DENISON ST**

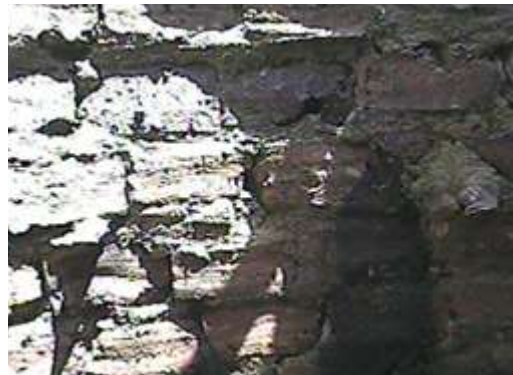
Defect 1

Steps Count: **3** Missing: **1** ☒ **Corroded**

CORRODED / MISSING RUNG

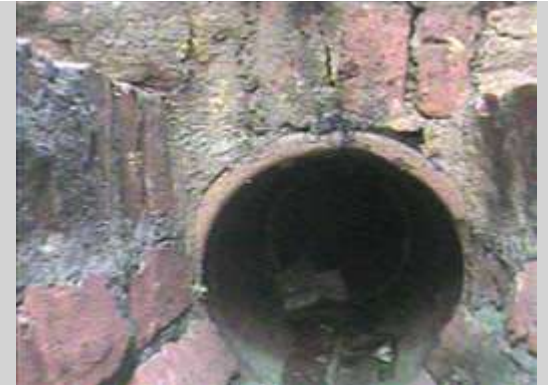
12 O'Clock Outflow

8 in. Circular Gravity Sewer
Pipe Out @ 12 O'Clock

Pipe Height: (in.) Direct
Pipe Material: **Clay** ☐ Pipe Lined
Invert Depth: **6.81** (ft.) Flow Characteristics: **Slow**
Deposits: ☒ None ☐ Mud ☐ Sludge ☐ Debris ☐ Grease
Silt Depth: (in.) Deposits Extent:
Infiltration: **None** Pipe Seal Cond: **Cracked**

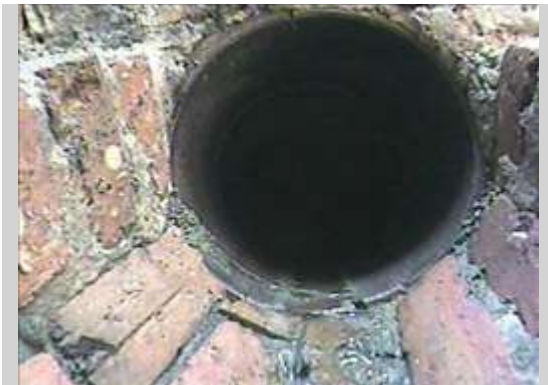
3 O'Clock Inflow

8 in. Circular Gravity Sewer
Pipe In @ 3 O'Clock

Pipe Height: (in.) Direct
Pipe Material: **Clay** ☐ Pipe Lined
Invert Depth: **6.40** (ft.) Flow Characteristics: **Slow**
Deposits: ☒ None ☐ Mud ☐ Sludge ☐ Debris ☐ Grease
Silt Depth: (in.) Deposits Extent:
Infiltration: **None** Pipe Seal Cond: **Sound**

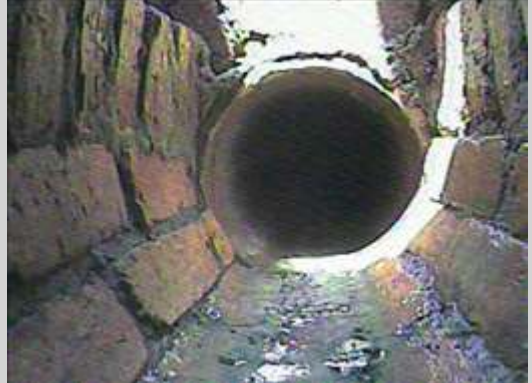
6 O'Clock Inflow

8 in. Circular Gravity Sewer

Pipe In @ 6 O'Clock

Infiltration: **None** Pipe Seal Cond: **Cracked**
